# Anterior Segment OCT Image of Vitreous Hernia

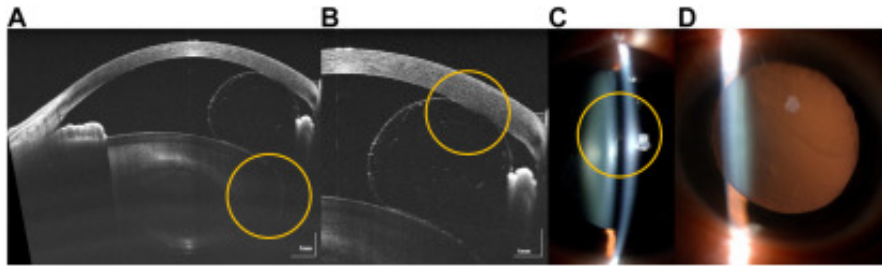
A 47-year-old male building maintenance worker was injured by the connection hook on a lanyard. **A**, The anterior chamber image reveals lens subluxation with the vitreous herniating into the anterior chamber around the lens edge as observed on anterior segment OCT (**B**). The herniated vitreous touched the corneal endothelium. **C**, The vitreous hernia was barely visible on slit-lamp biomicroscopy image; however, it could be observed on the retro-illumination image captured on the slit-lamp (**D**). (Magnified version of Figure **A-D** is available online at [www.aaojournal.org](http://www.aaojournal.org)).
